St. Mary's River Watershed Plan

Center for Watershed Protection

8/2/2012

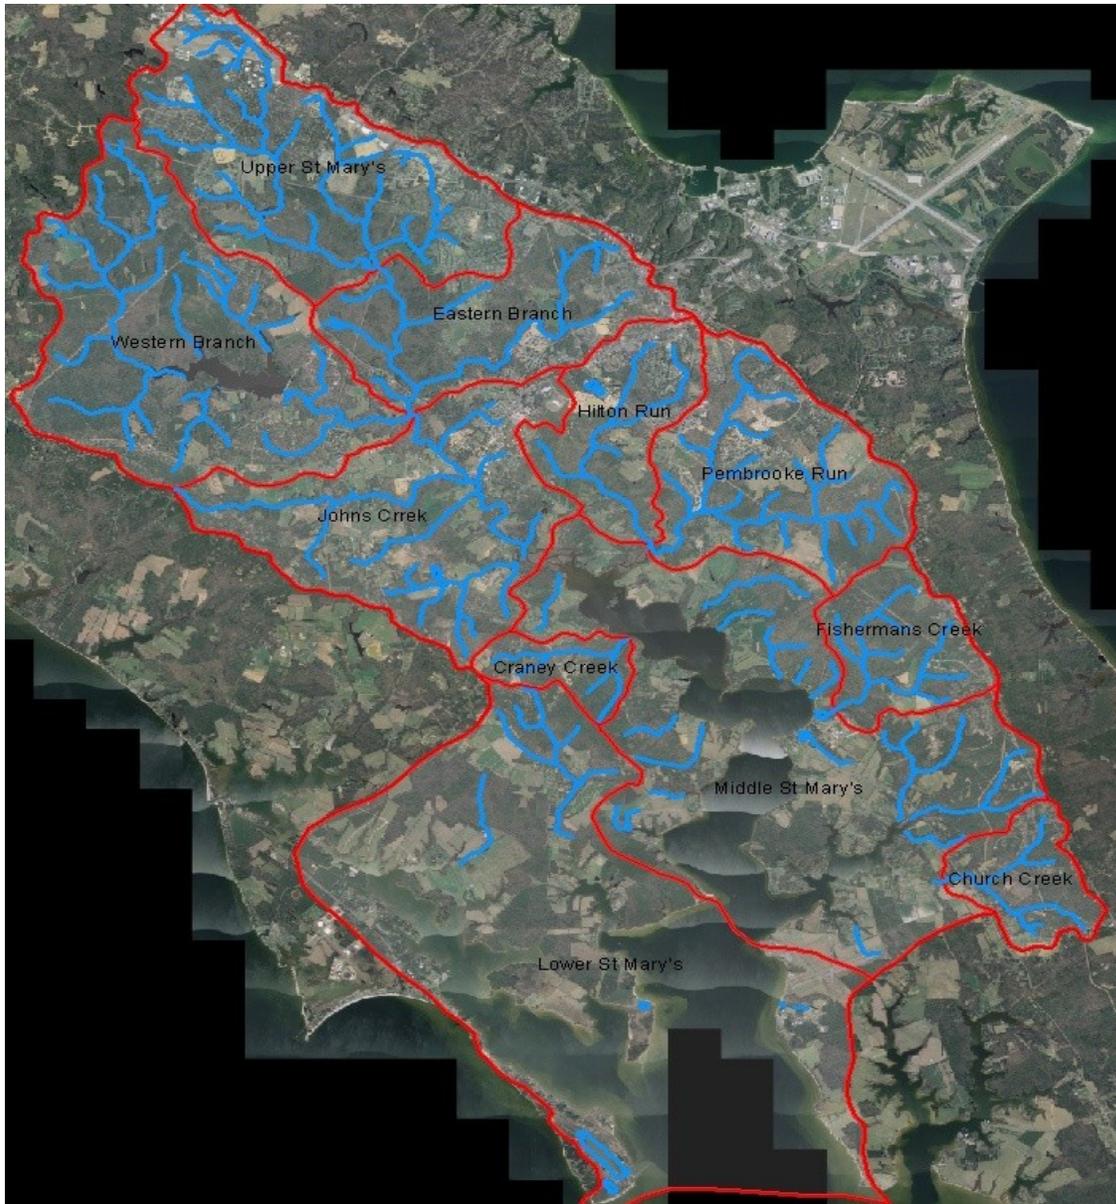
Figure 1. St. Mary's River Subwatersheds

The stream network is 175 miles in length, and is divided among 10 subwatersheds (Table 1 and Figure 1). The tidal St. Mary's River is approximately 12 km in length. A 2008 Stream Corridor Assessment conducted by St. Mary's College found that most of the streams are healthy and are generally protected by forest buffers. However, isolated areas of erosion occur especially in areas of high impervious cover and road crossings.

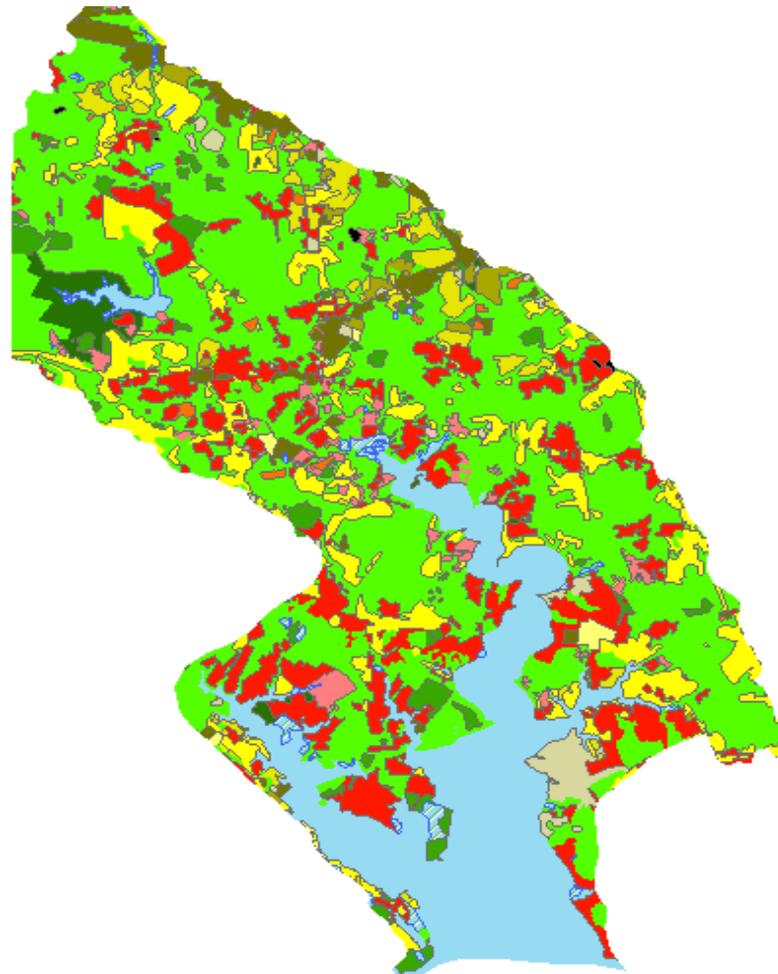
Figure 2. Land Uses in the Watershed

Developed areas in the St. Mary's River watershed, such as Lexington Park, California, and Great Mills, are often described as "Urban." This classification includes residential commercial, industrial and institutional land uses as well as the transportation network, roads, sidewalks, and railroads. Stormwater from developed areas can contribute pollution from fertilizers, pet waste, and fluids and emissions from vehicles. Additionally impervious surfaces associated with rooftops, roads, and parking lots generate large volumes of stormwater which can significantly damage and alter streams.

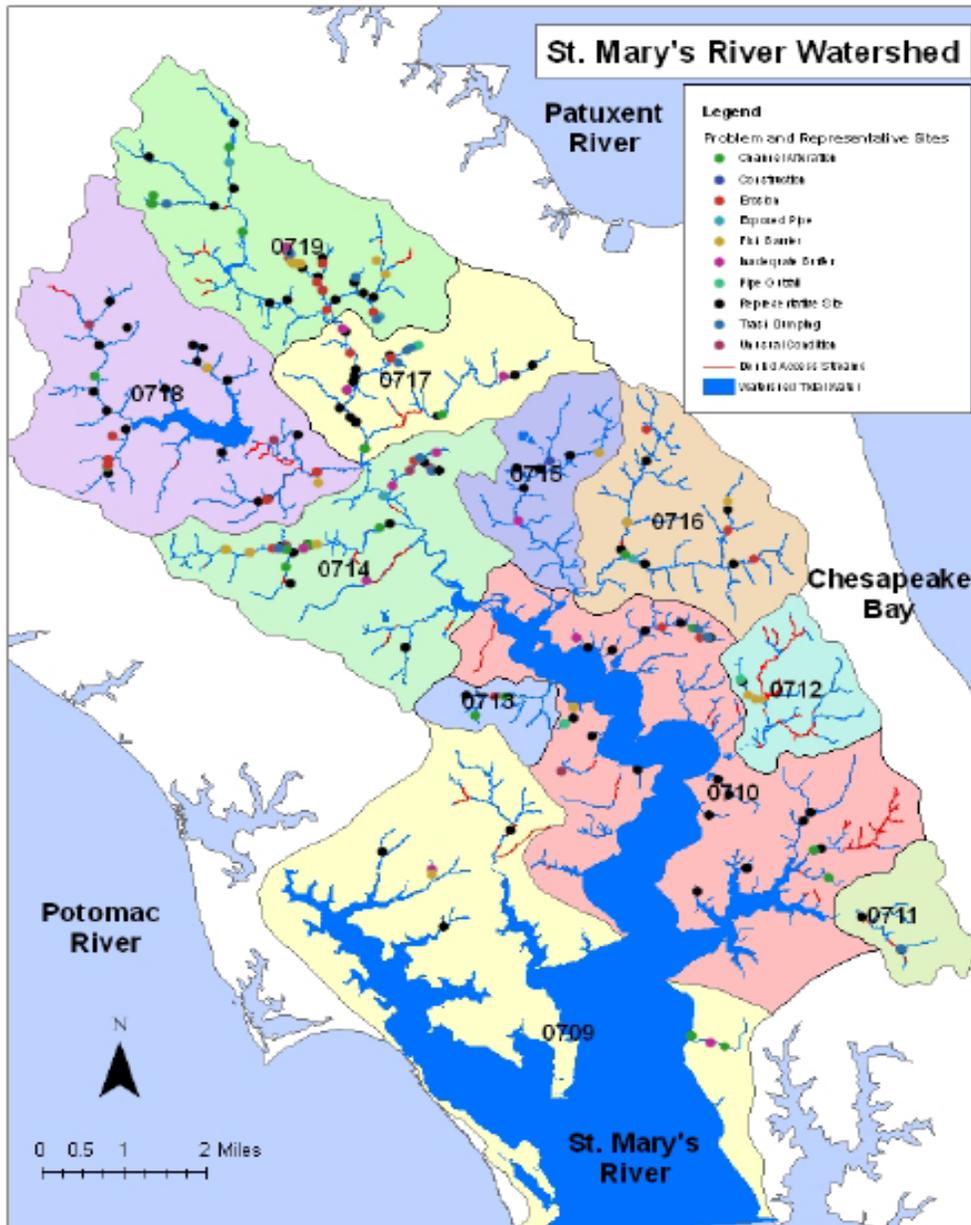
Figure 3. Map of representative and problem sites in the watershed

The survey crew identified 119 potential problem sites and recorded basic habitat information at 98 representative sites (Figures 3 and Table 6). The most frequently observed environmental problem was erosion (29 sites), followed by channel alteration

(22 sites). In addition, there were 19 fish barriers, 14 inadequate stream buffers, 13 trash dumping sites, 8 pipe outfalls, 8 unusual conditions, 4 exposed pipes, and 2 construction sites. Of the 119 problem sites 10 were classified as being severe, and included 3 unusual conditions, 3 fish migration barriers, and one each from the erosion, exposed pipe, channel alteration, and inadequate buffer categories. The problems sites were clumped in large subwatersheds, along the main stem of the river, and in the more urbanized parts of the watershed. 76.5% of the identified problems were rated as moderate (30), low (32) and minor.

The Johns Creek (714) and Upper St. Mary’s River (719) subwatersheds had significantly more problems than any other watershed followed by Eastern Branch (717), Western Branch (718), and Middle St. Mary’s River (710) sub-watersheds with an intermediate number of problems. The Lower St. Mary’s River (709), Church Creek (711), Fishermans Creek (712), Craney Creek (713), Hilton Run (715), and Pembroke Run (716) subwatersheds were in relatively good condition. This trend indicated that impervious surfaces are one of the largest contributors to stream degradation.

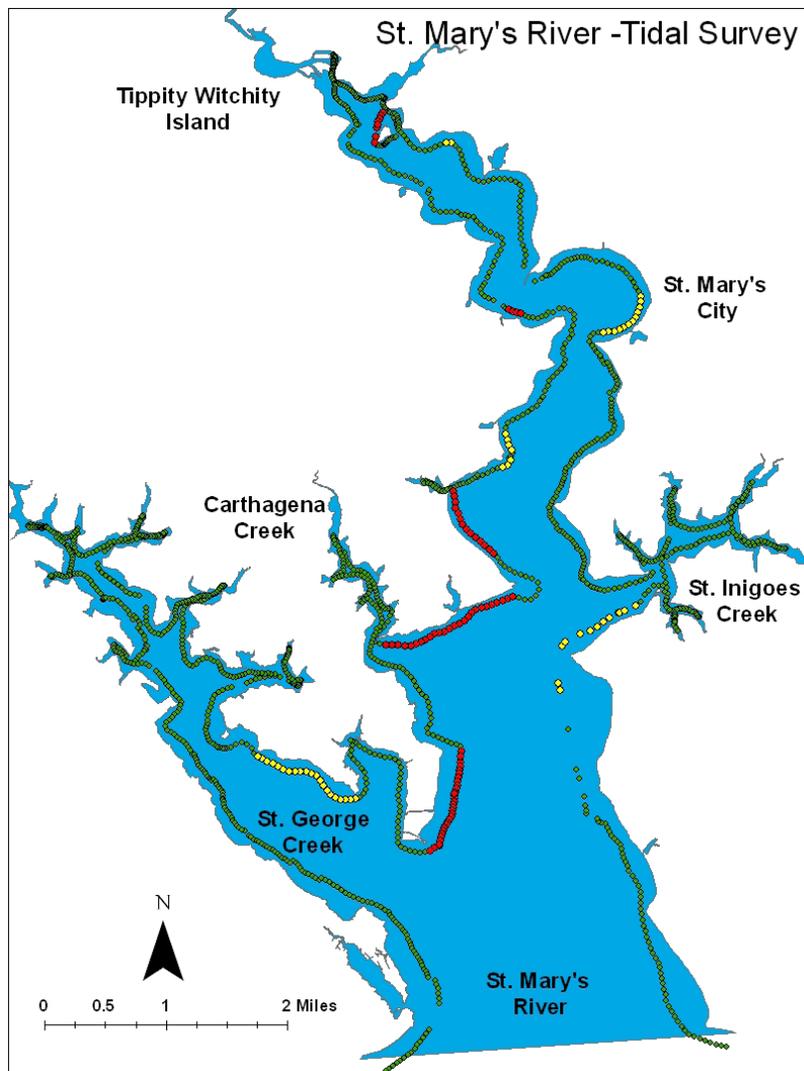
Figure 4. Tidal shoreline of the St. Mary's River with an assessment of shoreline stability. (Green markers indicate stable shoreline, red markers show shoreline erosion sites, and yellow markers show shoreline segments with inadequate buffering)

The tidal shoreline assessment involved surveying the shoreline by boat to identify erosion and other problems. The shoreline of the tidal portion of the St. Mary’s River is mainly comprised of private, residential lands, but also includes some areas of farmland, small commercial ventures such as marinas, Webster Field, and St. Mary’s College of Maryland. The most densely populated section of the river is St. Inigoes Creek, closely followed by the south side of St. George’s Creek. The principal problems observed on the tidal shoreline of the River appear to be inadequate buffers and erosion (Figure 4).

Another erosion site exists on the up-river side of Tippity Witchity. While fairly sheltered, and, by the appearance of flora on the bank, not eroding rapidly, this bank is approximately two meters high. A similar erosion site appears on the southern shoreline in the bend above Pagan Point. The most severe erosion site on the river is located on the western shore across from Chancellor's Point. At this site, an inadequate buffer has resulted in the erosion of a bank approximately 4 meters high and several hundred meters long. A similar problem may be seen around the point to the south, where a bank approximately 2 meters high and several hundred feet long is eroding between the green number 3 channel marker and Carthage Creek.

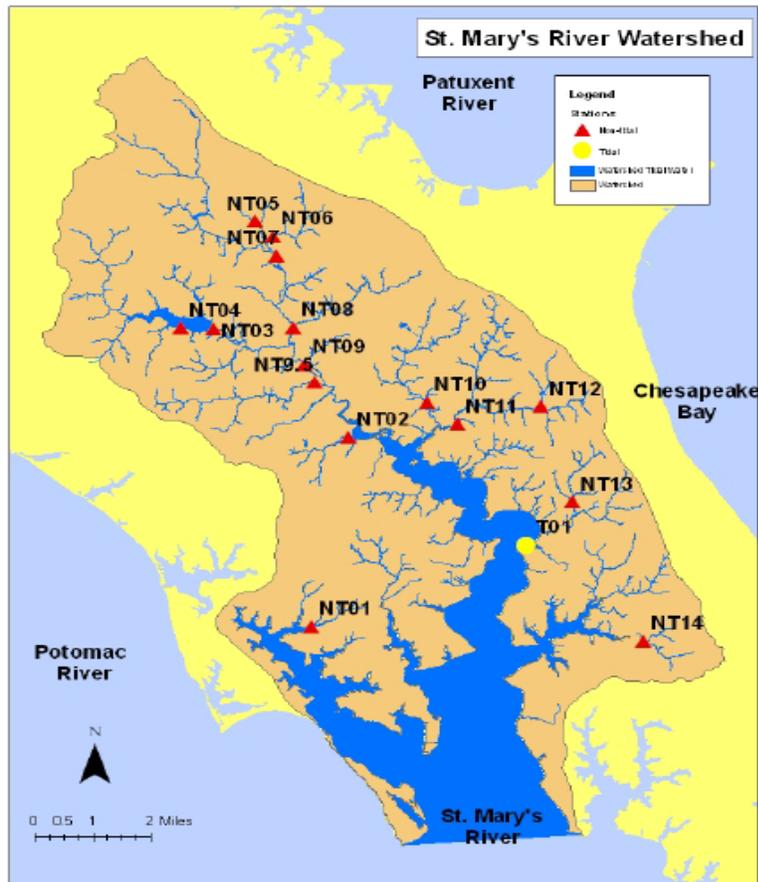
Figure 5. St. Mary's River Watershed Synoptic Stations

The 2008 synoptic survey included water quality monitoring and nutrient analyses at 15 non-tidal stations and a single station at the mid-point of the tidal reach (Figure 5). Biological sampling also occurred in April for macroinvertebrates and in July for fish. All procedures followed Maryland Biological Stream Survey (MBSS) protocols (Kayzak, 1997).

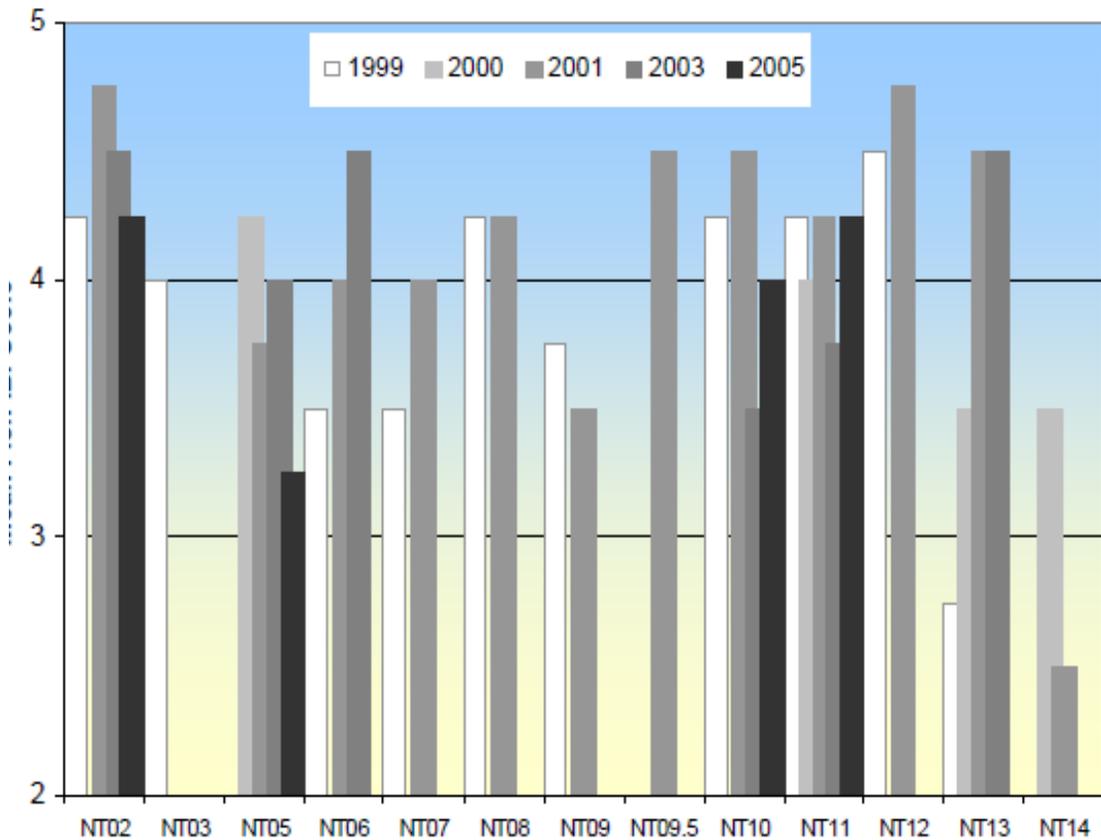
Figure 6. Mean IBI Scores for non-tidal fish communities at St. Mary's River stations

not supported. The site with the highest mean IBI scores and with at least 4 scores was NT02, Warehouse Run. In contrast to Church Creek, Warehouse Run has good in-stream habitat, a high aquatic insect diversity and cold water temperatures year-round. Some other stations with high IBI scores, such as NT11 (Pembrook Run), have fairly high IBI score despite clear signs of habitat degradation. For the most part, year-to-year IBI scores were consistent and did not range greater than one 1.0 IBI score. The authors of the study concluded that the conditions at stations, as measured by fish community diversity, were relatively stable and had not changed much from 1999 - 2008.

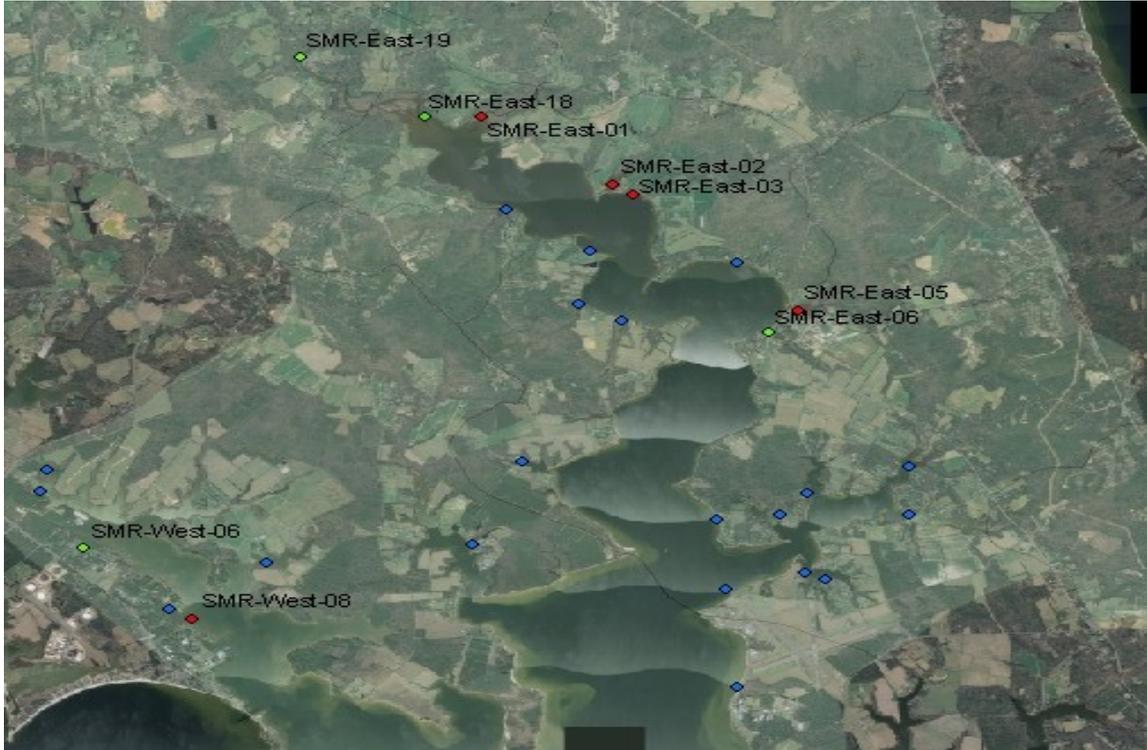
Figure 7. IDDE Sites with Positive Results (red=ammonia, green=total coliforms)

Using the same protocol, the west side of St. Mary's River had indicators for ammonia at 1 site, West-08, and there was 1 site that had indicators for Total coliform, West-06 (Table 9 and Figure 7). It should be noted, however, that E. Coli was found at all but 4 sites in the river.

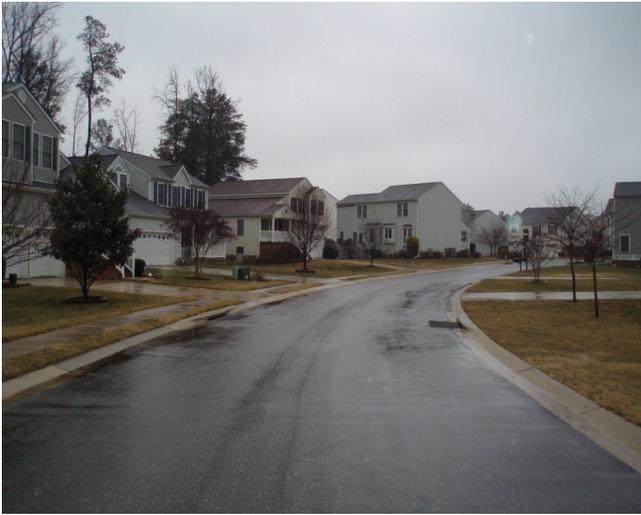
Figure 8. Possible site for residential retrofit

Key restoration practices identified as applicable in the residential areas of the St. Mary’s River watershed include bioretention and infiltration, pervious surface installation, removal of sediment from roadside swales and storm drain stenciling. Bioretention and infiltration retrofits are shallow, landscaped depressions that contain a layer of prepared soil, a mulch layer, and vegetation. These areas provide filtering of stormwater runoff by temporarily ponding water during storms, aiding in sediment and nutrient storage. Bioretention facilities have artificially constructed underground drainage systems, while infiltration facilities allow runoff to absorb into the existing soil at sites when infiltration rates are adequate (typically greater than 0.5 inches per hour).

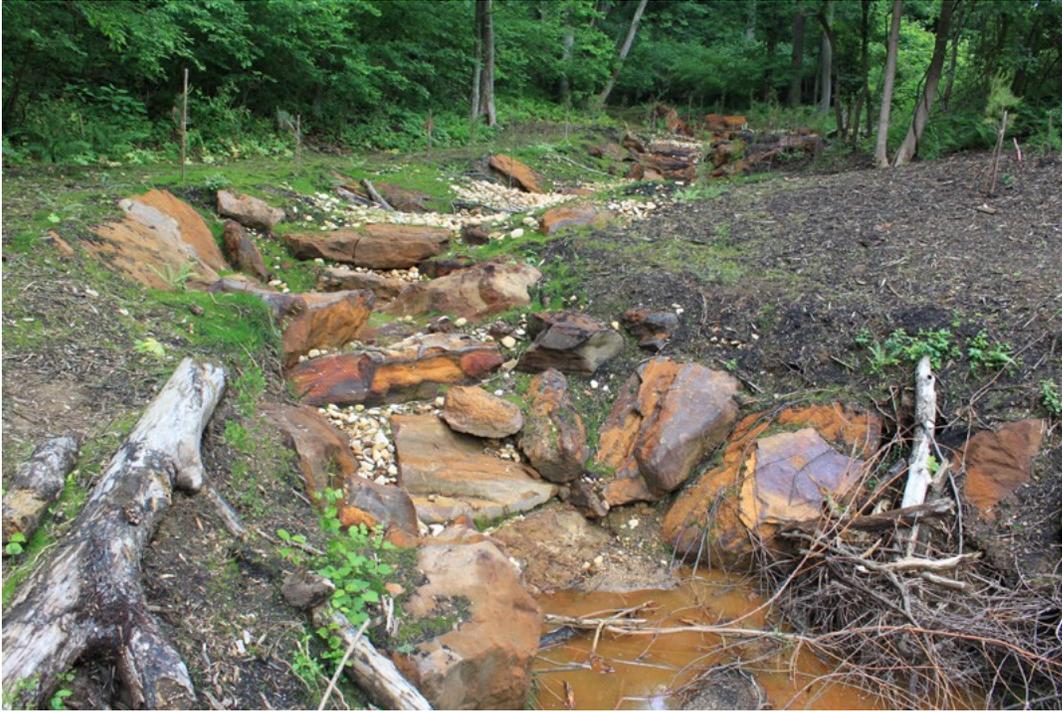
Figure 9. Regenerative Stormwater Conveyance (Underwood & Associates)

underlying sand channel to convey storm flow, and infiltrate stormwater to allow for the treatment and removal of pollutants and recharge of groundwater. RSC systems combine the features and treatment benefits of a number of retrofit practices including swales, infiltration, filtering, and wetland practices. Regenerative stormwater conveyances have been successfully constructed in many other coastal plain locations (Figure 9), and have been used with success in the State of Maryland.

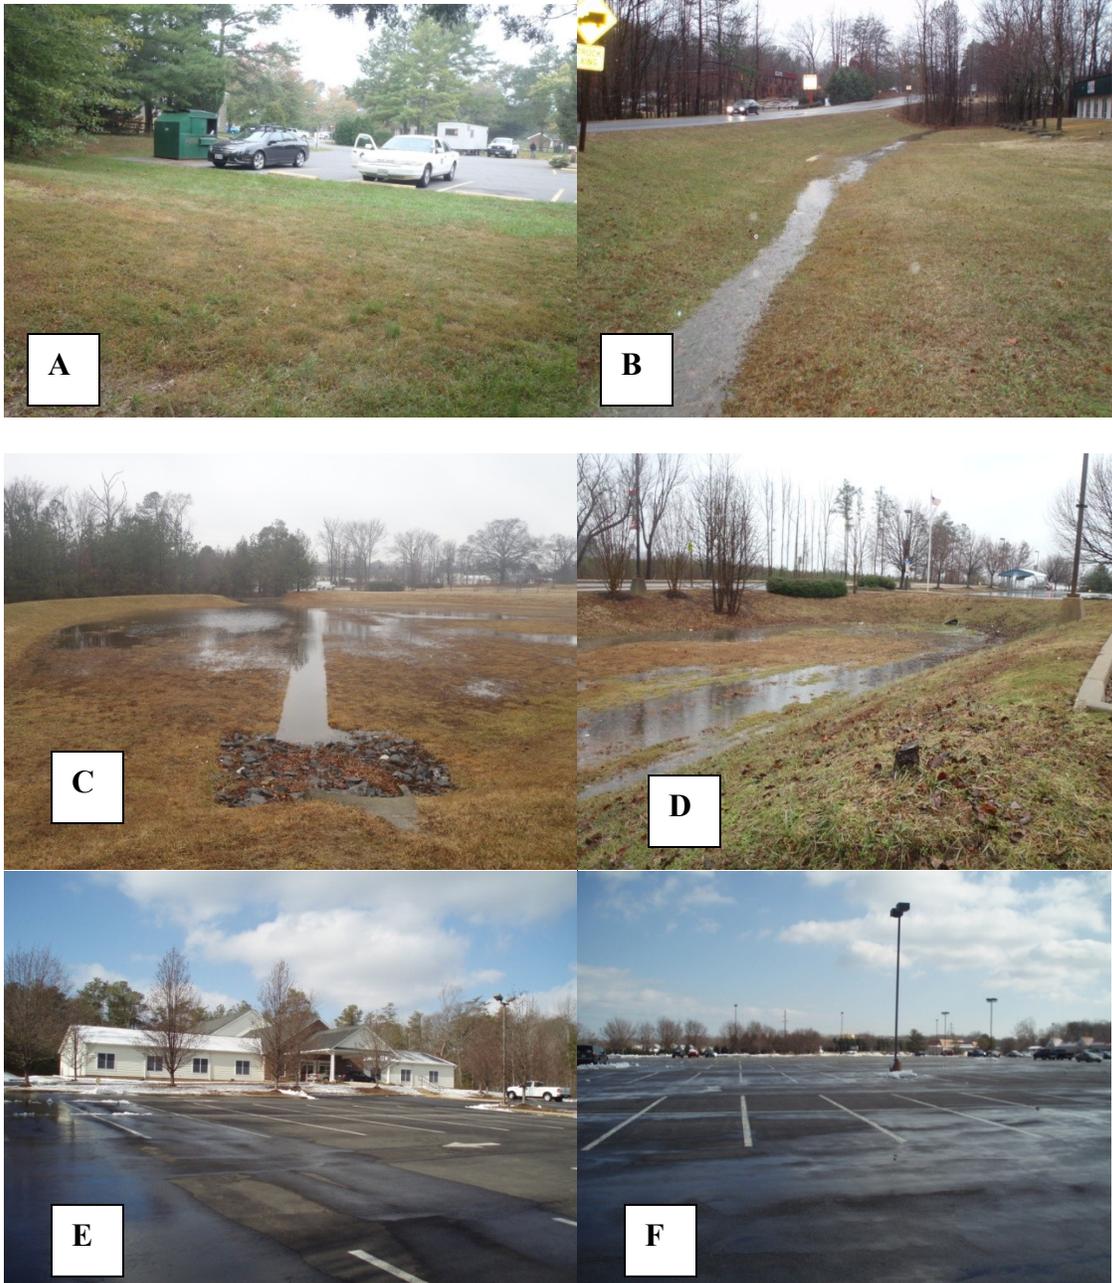
Figure 10. Stormwater Retrofit Inventory

A) Low-to-Moderate Workforce housing bioretention site. B) Potential bioswale location at St. Mary's Industrial Park. C) Stormwater pond retrofit site at Great Mills High School. D) Stormwater pond retrofit site at McKay's shopping center. E) Parking lot sheet flow to dry pond at Church of Christ. F) Large parking lot at Wildwood shopping center generating significant runoff.

Figure 10 presents some examples of locations in the St. Mary's watershed where stormwater retrofits can be implemented to provide volume reduction and pollutant treatment. Table 13 provides a summary of 37 potential retrofit sites visited and the proposed retrofit projects developed for each site. All of the sites were visited during the field work done in 2011, although some of the proposed retrofit projects were from the original field work completed in 2002. A brief description is provided, along with the estimated drainage area treated. Appendix A has a map of the St. Mary's watershed with the location of each retrofit, and Appendix D has the concept sheets for 7 projects.

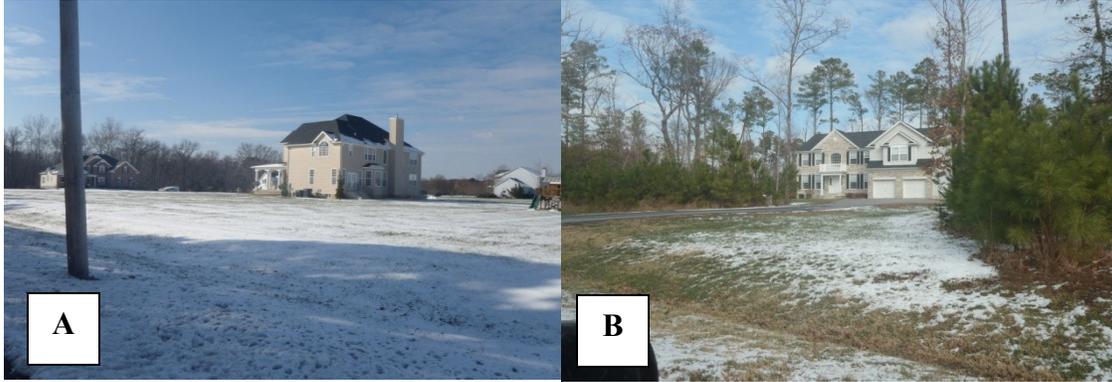
Figure 11. Neighborhood Source Assessments

A) Example of residential lot with no tree cover. B) Example of residential lot with significant tree cover.

Residents and businesses may engage in behaviors and activities that can influence water quality both negatively and positively. Positive behaviors such as tree planting (Figure 11), disconnecting rooftops, and picking up pet waste can help improve water quality.

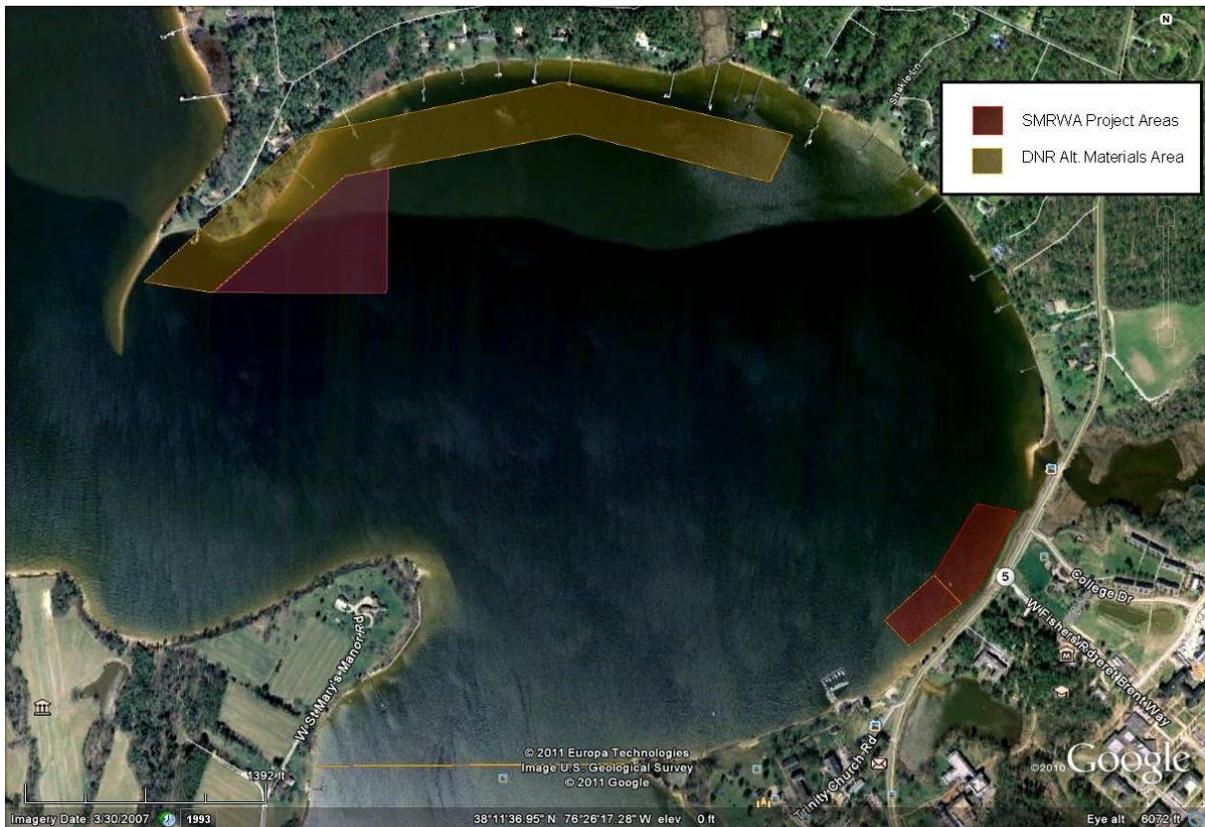
Figure 12. St. Mary's River Oyster Restoration Target Areas for Maryland DNR and St. Mary's River Watershed Association

Oysters are an important resource to the ecosystem, the economy, and the culture of the St. Mary's River Watershed and Chesapeake Bay region as a whole and comprehensive oyster restoration is paramount to a restored Chesapeake Bay. Historically the St. Mary's River contained 2,461 acres of suitable oyster habitat; however, combinations of overharvesting, loss of habitat, disease, and poor water quality have resulted in significant declines in both oyster populations and suitable reef habitat (USACE 2012). The U.S. Army Corps of Engineers' (USACE) in close partnership with the Maryland Department of Natural Resources and the Virginia Marine Resources Commission developed a native oyster restoration master plan that presents a strategy for large-scale, concentrated oyster restoration throughout the Chesapeake Bay and its tributaries. *The Chesapeake Bay Oyster Recovery: Native Oyster Restoration Master Plan* identifies that 19 (Tier 1) tributaries in the Chesapeake Bay are currently suitable for large-scale oyster restoration. Tier 1 tributaries are the highest priority tributaries that demonstrate the historical, physical, and biological attributes necessary to provide the highest potential to develop self-sustaining populations of oysters. The St. Mary's River is listed as a Tier 1 tributary and a goal of restoring 200 to 400 acres of oyster reef has been established (USACE 2012). A specific tributary plans should be developed for the St. Mary's River and include a refinement of the restoration target.

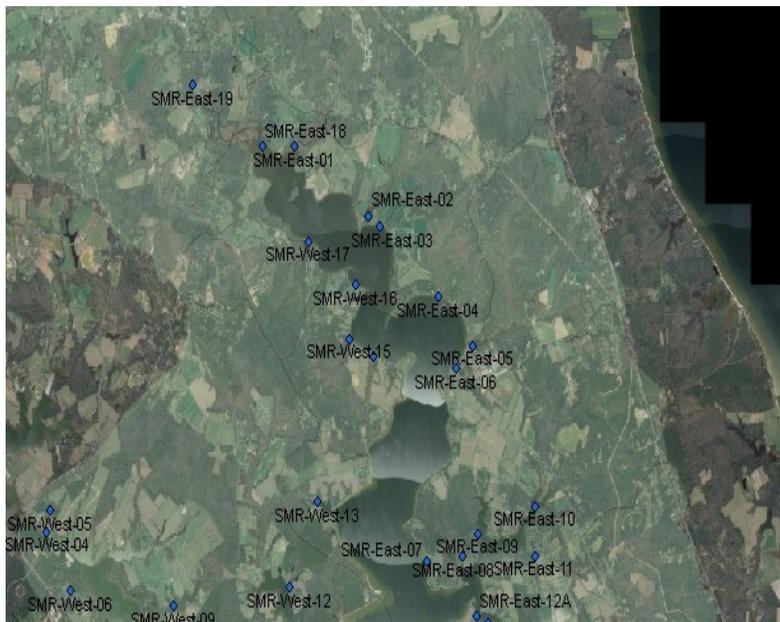
Figure B-1. Shoreline IDDE sampling Sites

Sites were selected to gain a snapshot understanding of where septic systems may be failing and where additional monitoring and outreach efforts should focus. Sites were selected where the shore line contained residential sites in the critical area, marinas, stream outfalls, and agriculture and forest land (Figure B-2). The teams utilized power boats driven by local

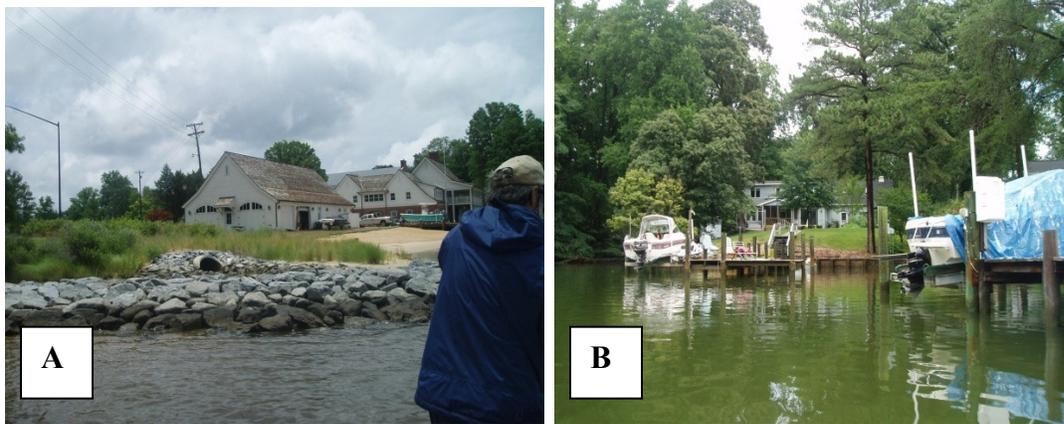
Figure B-2. Example Shoreline IDDE Sites
 A.) Monitoring location near St. Mary’s College East-06. B) Monitoring location near houses East-08

information; field crews used the Shoreline Survey Field Sheet (Appendix C) to record data collected at the site. Water quality samples were collected approximately 15 feet from shore at 2 feet deep. Samples were kept on ice until the end of the field day.

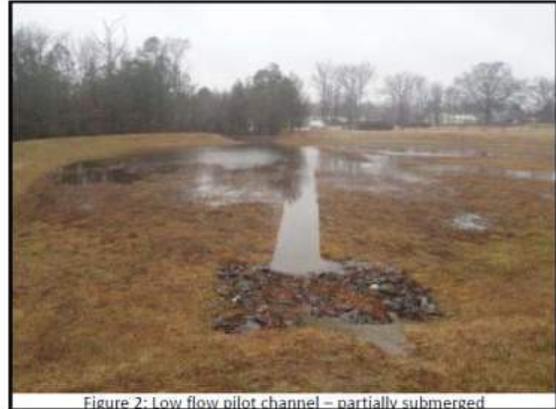
Figure 2: Low flow pilot channel – partially submerged

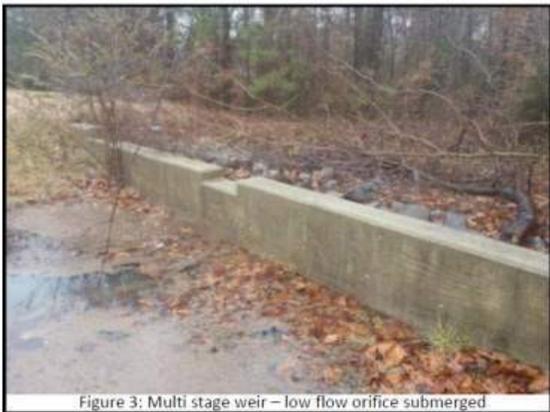
Figure 3: Multi stage weir – low flow orifice submerged

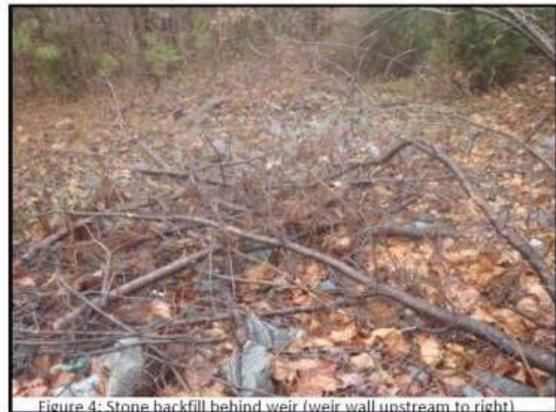
Figure 4: Stone backfill behind weir (weir wall upstream to right)

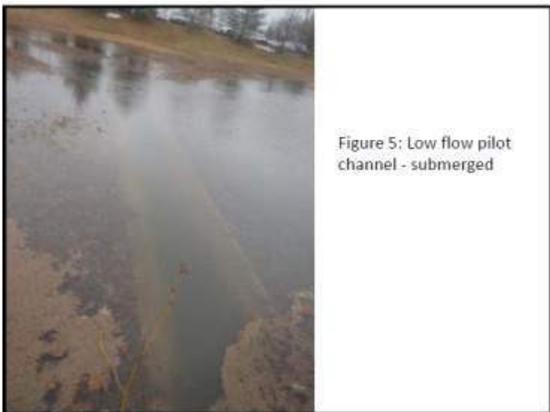
Figure 5: Low flow pilot channel - submerged

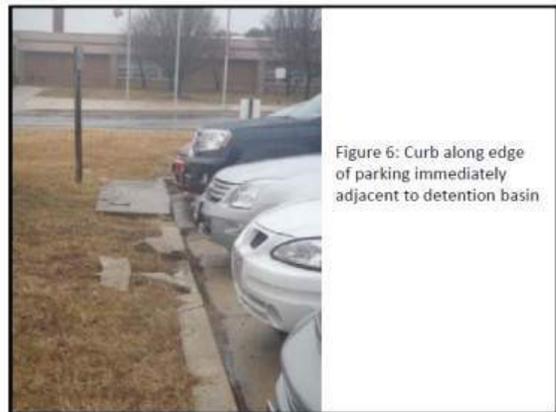
Figure 6: Curb along edge of parking immediately adjacent to detention basin

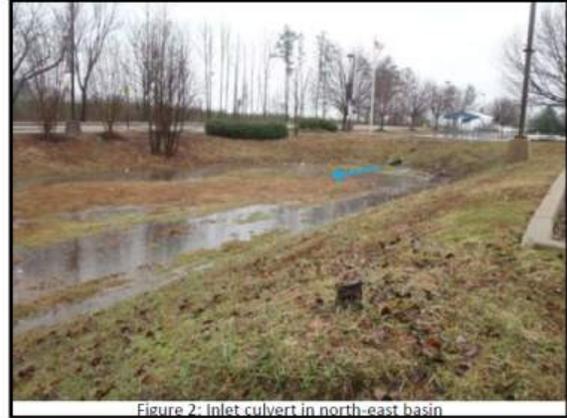
Figure 2: Inlet culvert in north-east basin

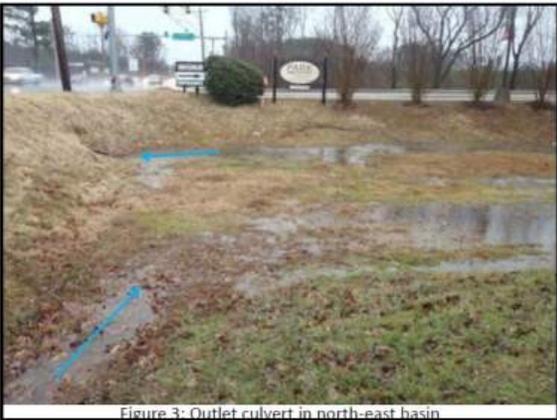
Figure 3: Outlet culvert in north-east basin

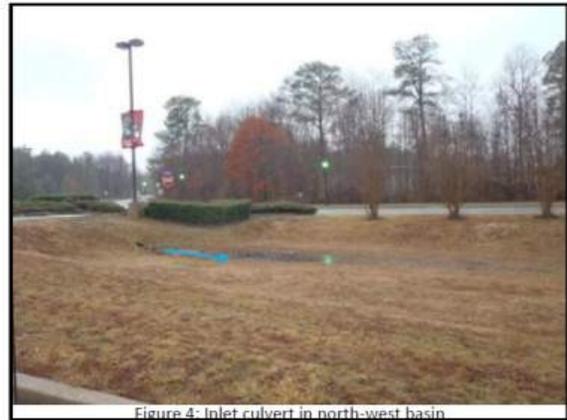
Figure 4: Inlet culvert in north-west basin

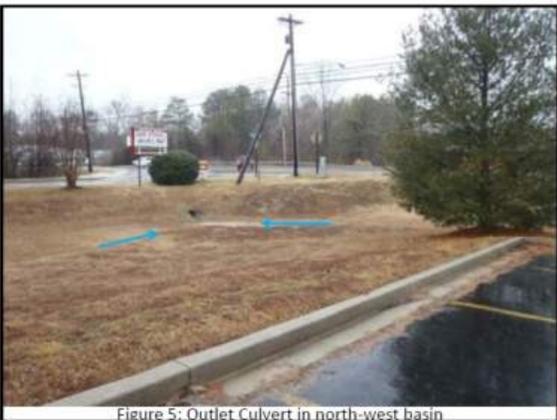
Figure 5: Outlet Culvert in north-west basin

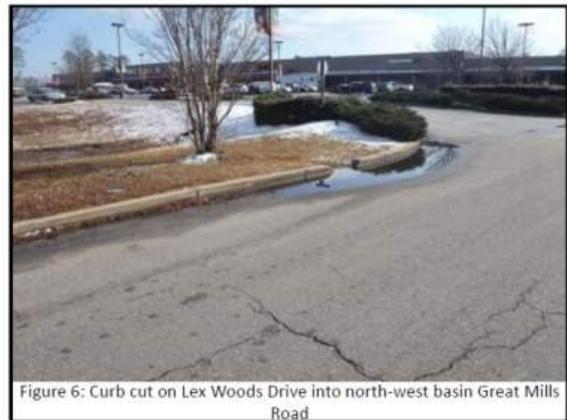
Figure 6: Curb cut on Lex Woods Drive into north-west basin Great Mills Road

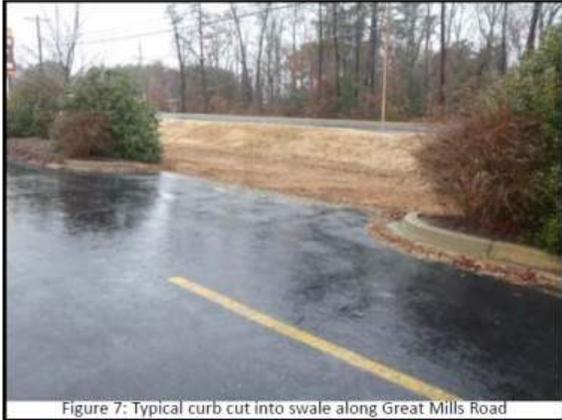
Figure 7: Typical curb cut into swale along Great Mills Road

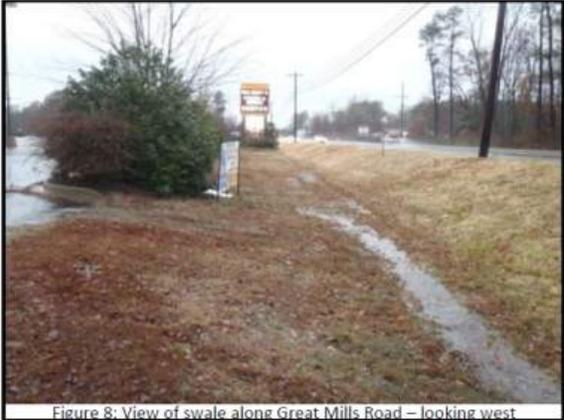
Figure 8: View of swale along Great Mills Road – looking west

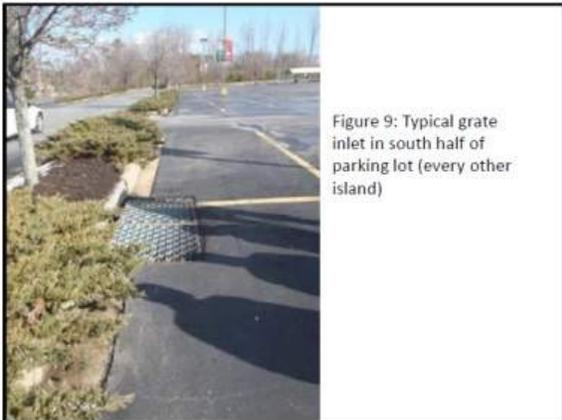
Figure 9: Typical grate inlet in south half of parking lot (every other island)

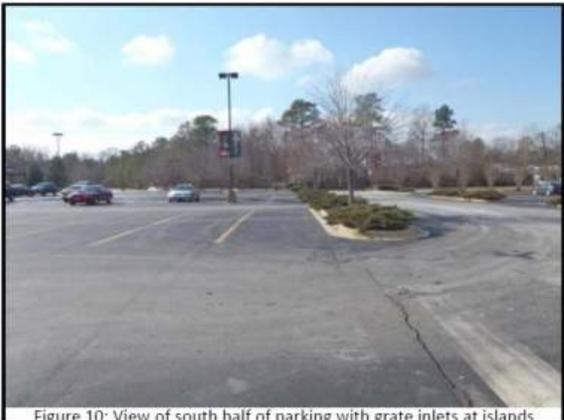
Figure 10: View of south half of parking with grate inlets at islands

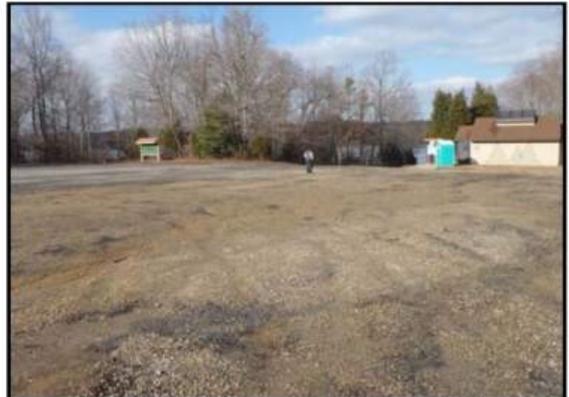
Figure 2: Parking lot looking Principal spillway CMP pipe

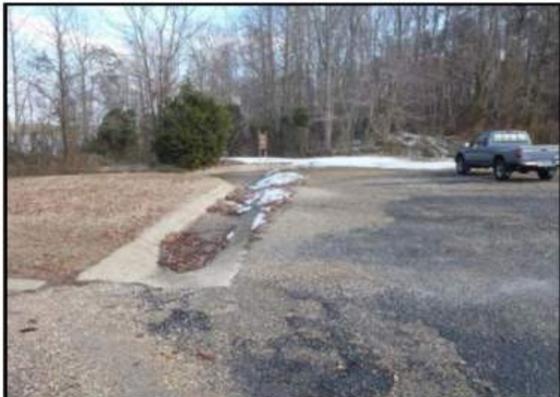
Figure 3: Drainage channel at bottom of parking area – looking east

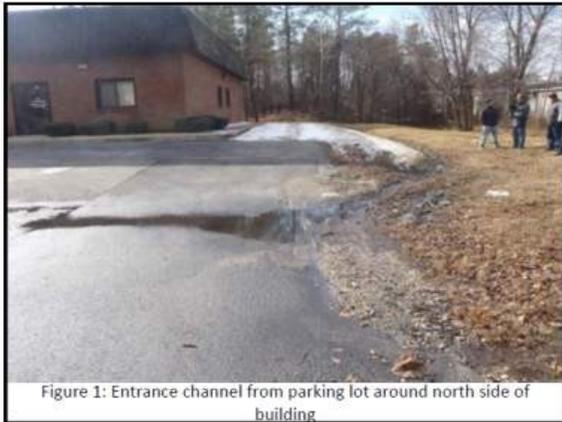
Figure 1: Entrance channel from parking lot around north side of building

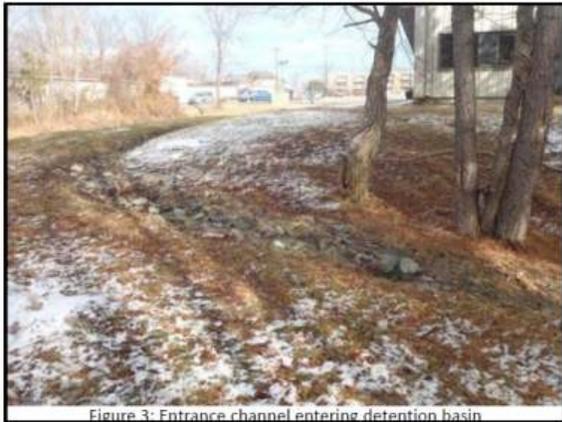
Figure 3: Entrance channel entering detention basin

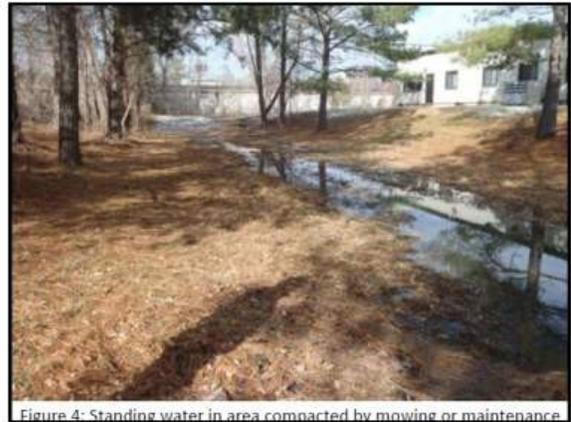
Figure 4: Standing water in area compacted by mowing or maintenance

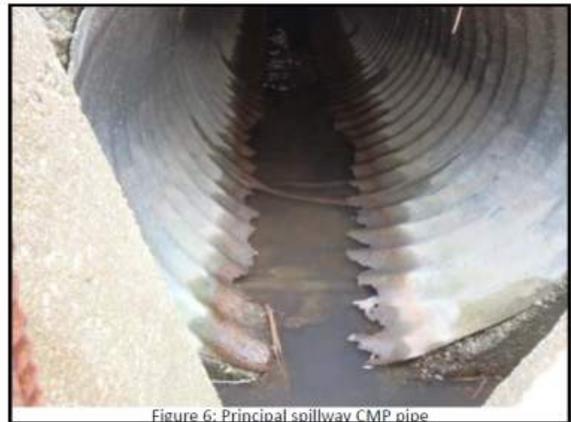
Figure 6: Principal spillway CMP pipe

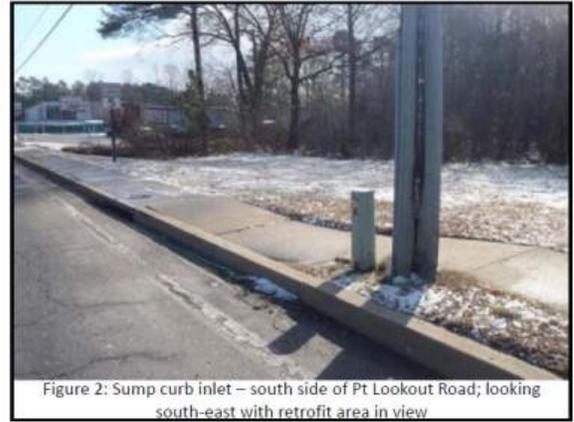
Figure 2: Sump curb inlet – south side of Pt Lookout Road; looking south-east with retrofit area in view

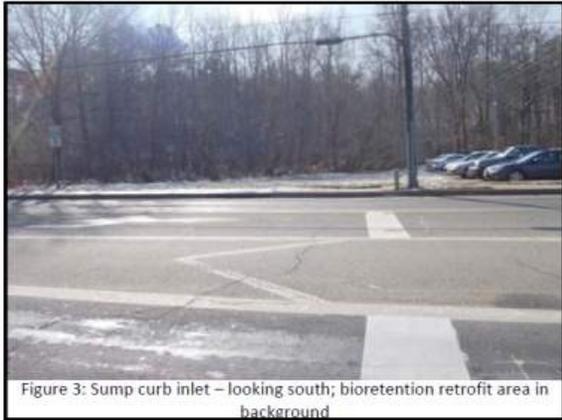
Figure 3: Sump curb inlet – looking south; bioretention retrofit area in background

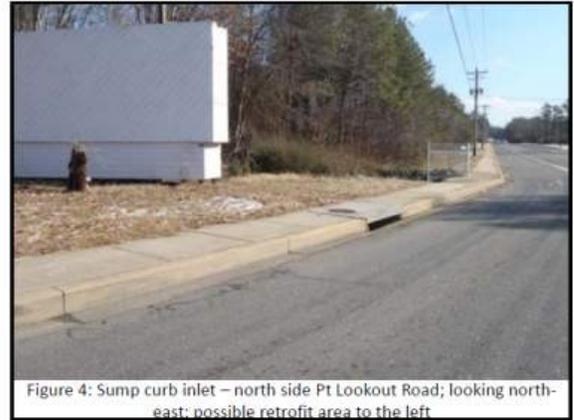
Figure 4: Sump curb inlet – north side Pt Lookout Road; looking north-east; possible retrofit area to the left

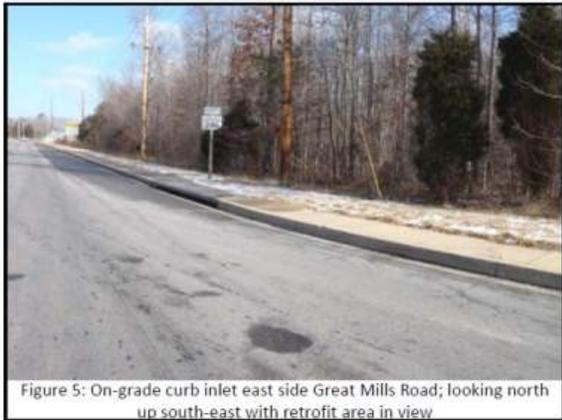
Figure 5: On-grade curb inlet east side Great Mills Road; looking north up south-east with retrofit area in view

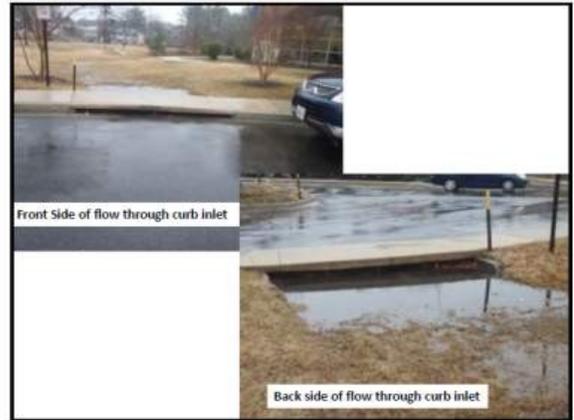
Front Side of flow through curb inlet

Back side of flow through curb inlet

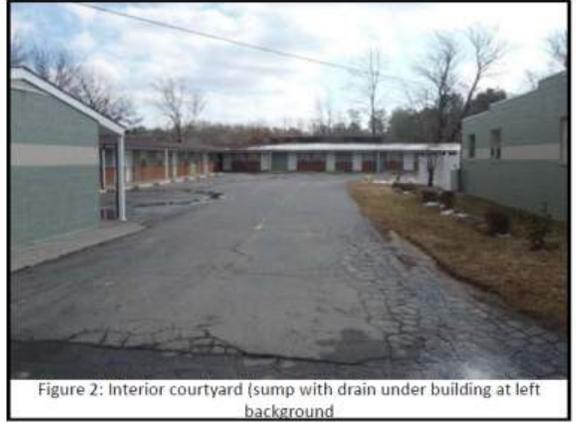
Figure 2: Interior courtyard (sump with drain under building at left background)

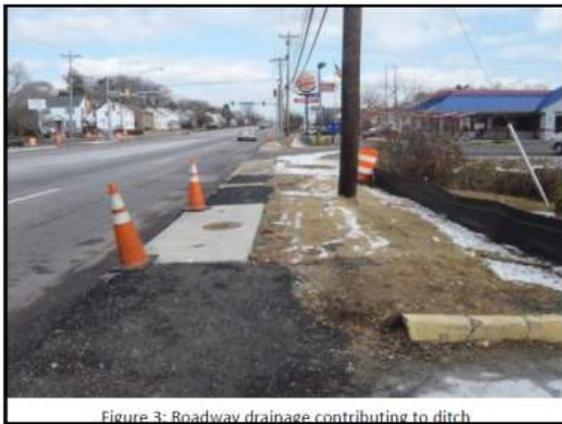
Figure 3: Roadway drainage contributing to ditch

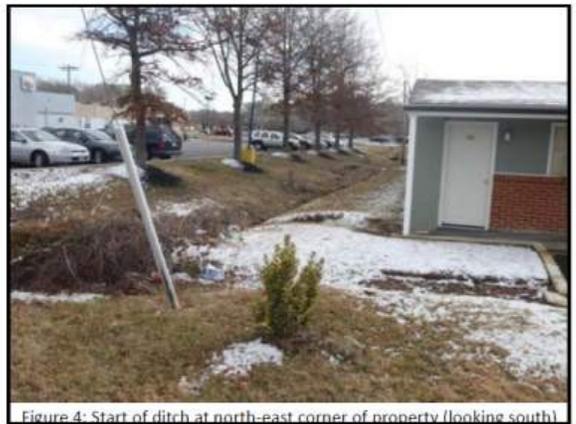
Figure 4: Start of ditch at north-east corner of property (looking south)

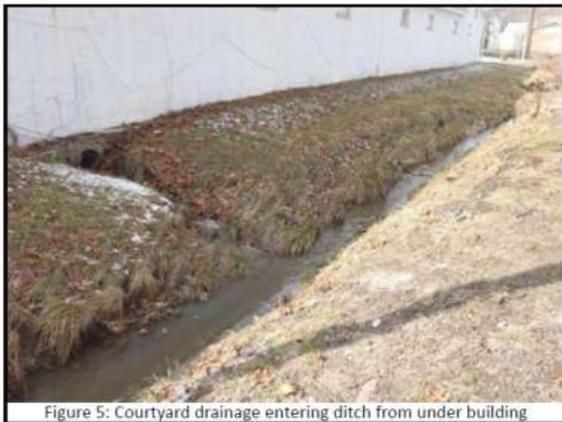
Figure 5: Courtyard drainage entering ditch from under building

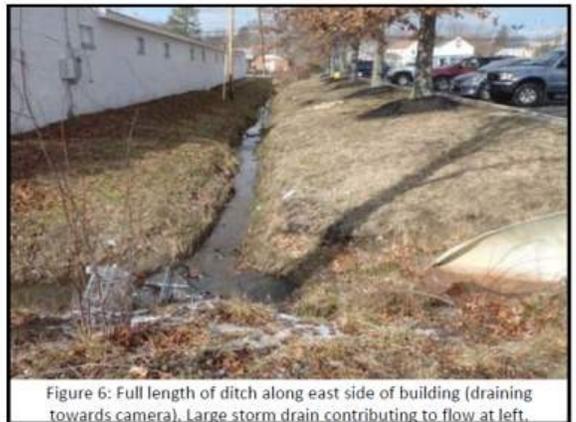
Figure 6: Full length of ditch along east side of building (draining towards camera). Large storm drain contributing to flow at left.

1. Implement stormwater attenuation in the upstream drainage areas (mostly built out and few opportunities for significant volume reduction or peak flow attenuation; or
2. Improve the channel conveyance capacity by either enclosed pipe or concrete channel from Great Mills Road to the receiving channel at the far south-west corner of the A&E property.

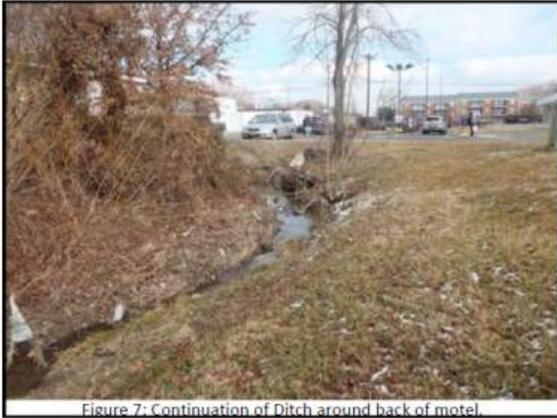
Figure 7: Continuation of Ditch around back of motel.

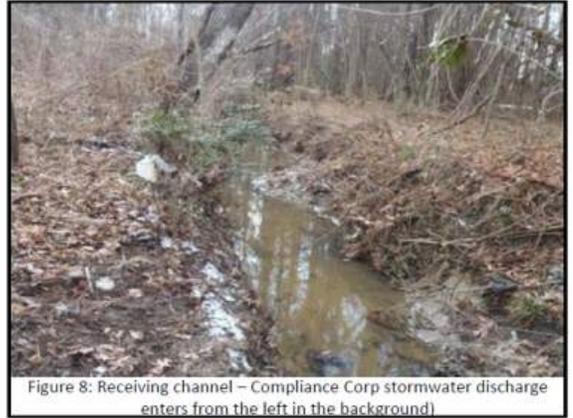
Figure 8: Receiving channel – Compliance Corp stormwater discharge enters from the left in the background)
